MAINTENANCE BUILDINGS
PIEDMONT UNIFIED SCHOOL DISTRICT
SEISMIC STRENGTHENING PROGRAM / MEASURE E BOND PROGRAM

INVESTIGATION AND ANALYSIS
FINAL REPORT

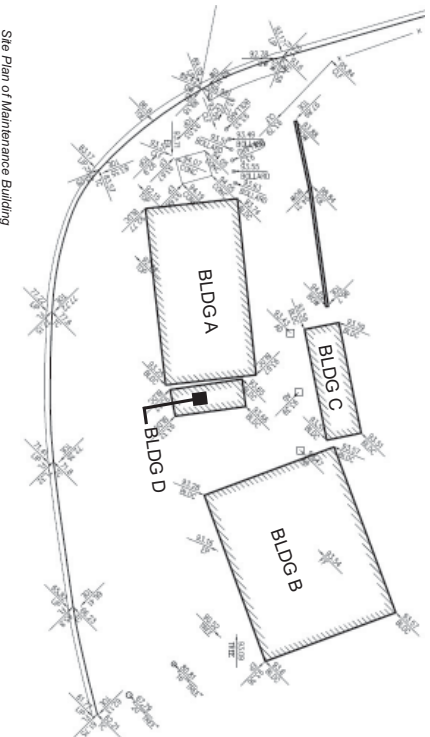
D. Building Descriptions

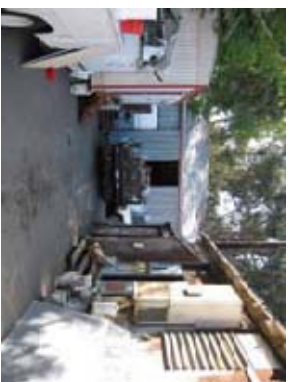
Building C – Large Trailer Office, Breakroom / Toilet

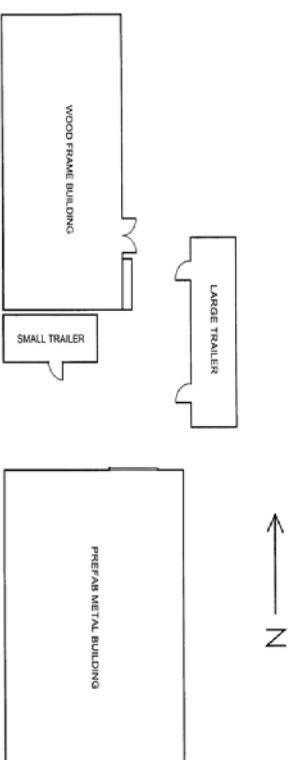
Figure 1 – Corporation yard site plan showing the approximate layout of buildings.

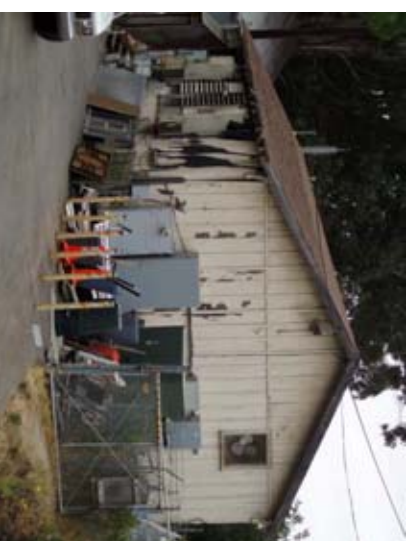
Figure 2 – Wood frame building. This is showing deterioration on its the exterior. The ends of many roof rafters are rotten and the paint is peeling off the siding in many places.

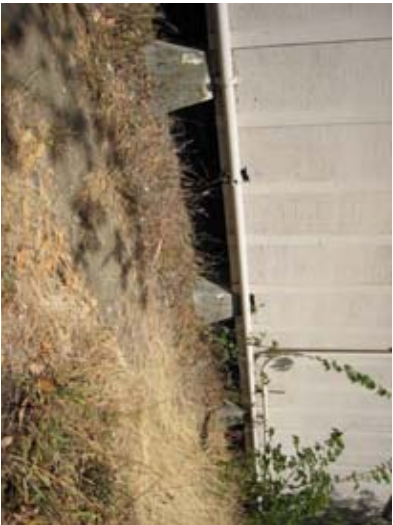
Figure 3 – The wood frame building is supported on one foot high precast concrete piers. These do not provide resistance to lateral forces.

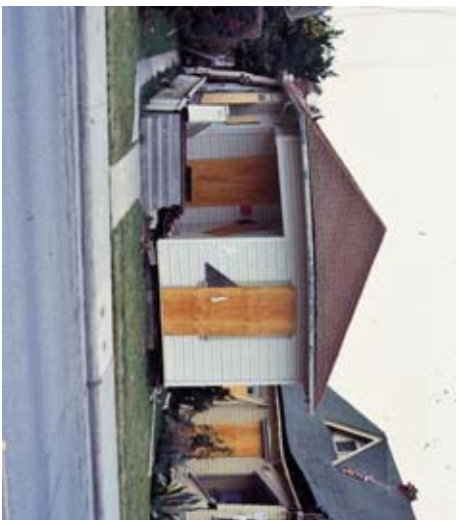
Figure 4 – This Watsonville house shifted off its foundation and fell to the ground during the 1989 Loma Pieta earthquake.

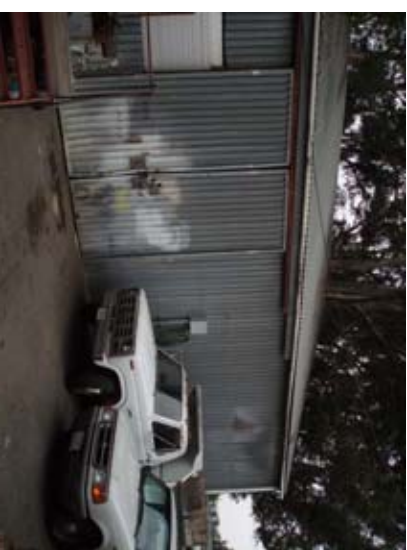
Figure 5 – Prefab metal building. This structure was relocated to the site from another location and is in relatively good condition for its age.

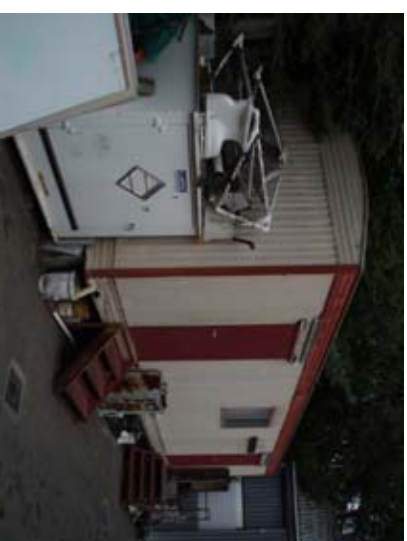
Figure 7 – Large trailer.

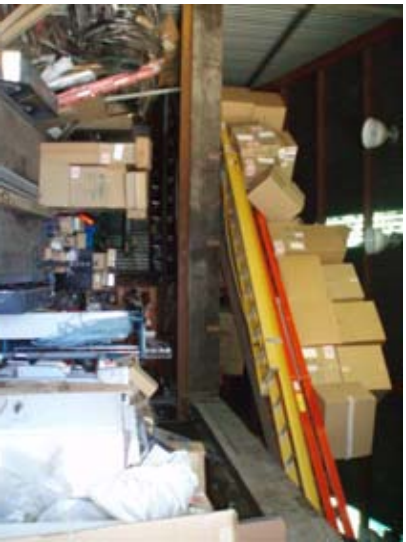
Figure 11 – Boxes are stored on a ladder placed horizontally. These constitute a falling hazard, and the storage arrangement does not meet ASCE 31 requirements.

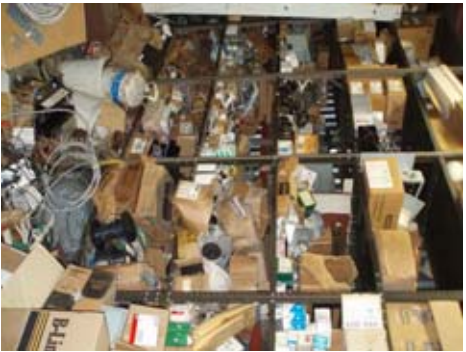
Figure 12 – The contents of these metal storage shelves can topple. Additionally, some shelves in the building are not anchored to the floor and can slide or tip over.
